Parks Canada Manuscript Report 459

Archaeological Excavations at the  
Newboro Lock Station, Rideau Canal  
Ontario, 1986-87

by Stephen F. Mills

1990

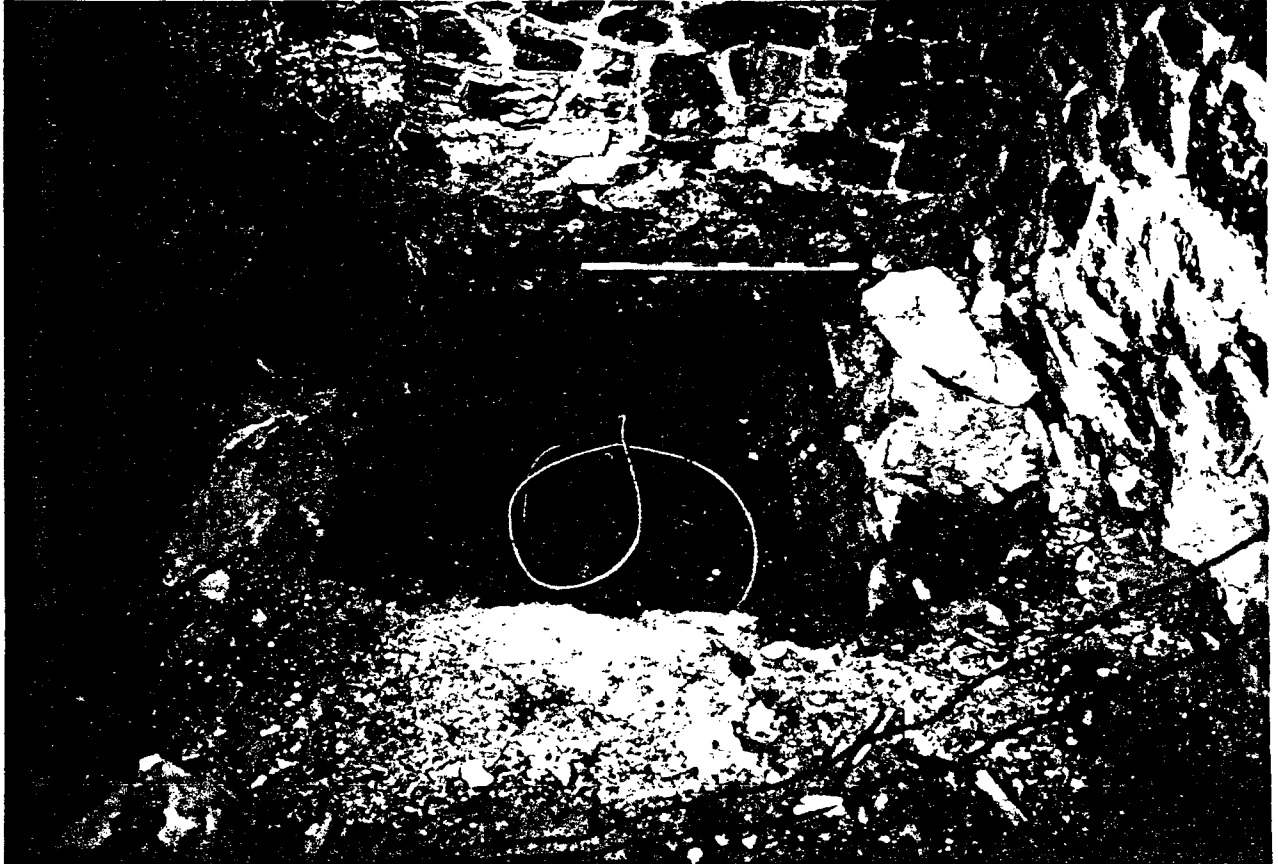
Figure 7. Stone sill, (beneath metre stick) and cut stone debris. (Photo by author; 24H-697T)

The removal of this layer revealed a stone ledge measuring 0.08m wide along the south foundation wall at a depth of 0.14m below the surface in unit 14G (Fig. 7) and 0.23m below the surface in unit 14J. In the south-west quadrant of the foundation, wood grain impressions remained in the mortar adhering to the stones of this sill (Fig. 8). These impressions suggests that large beams were placed on the ledge while the mortar was still wet. In unit 14J the ledge was covered with plaster and whitewash.

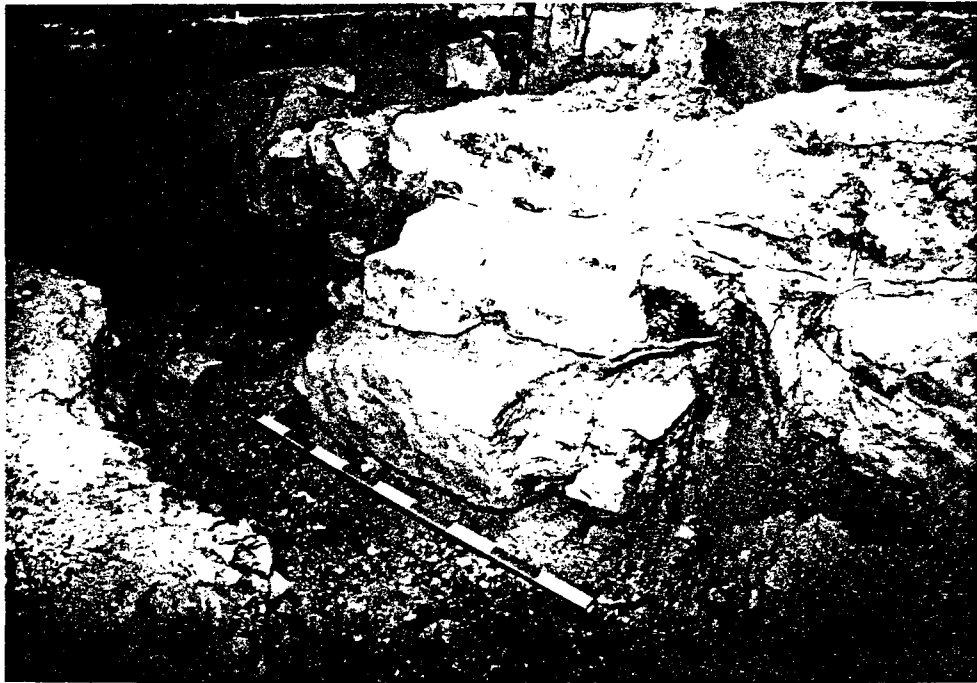
Figure 12. Detail of retaining wall. (Photo by author; 24H-971M)

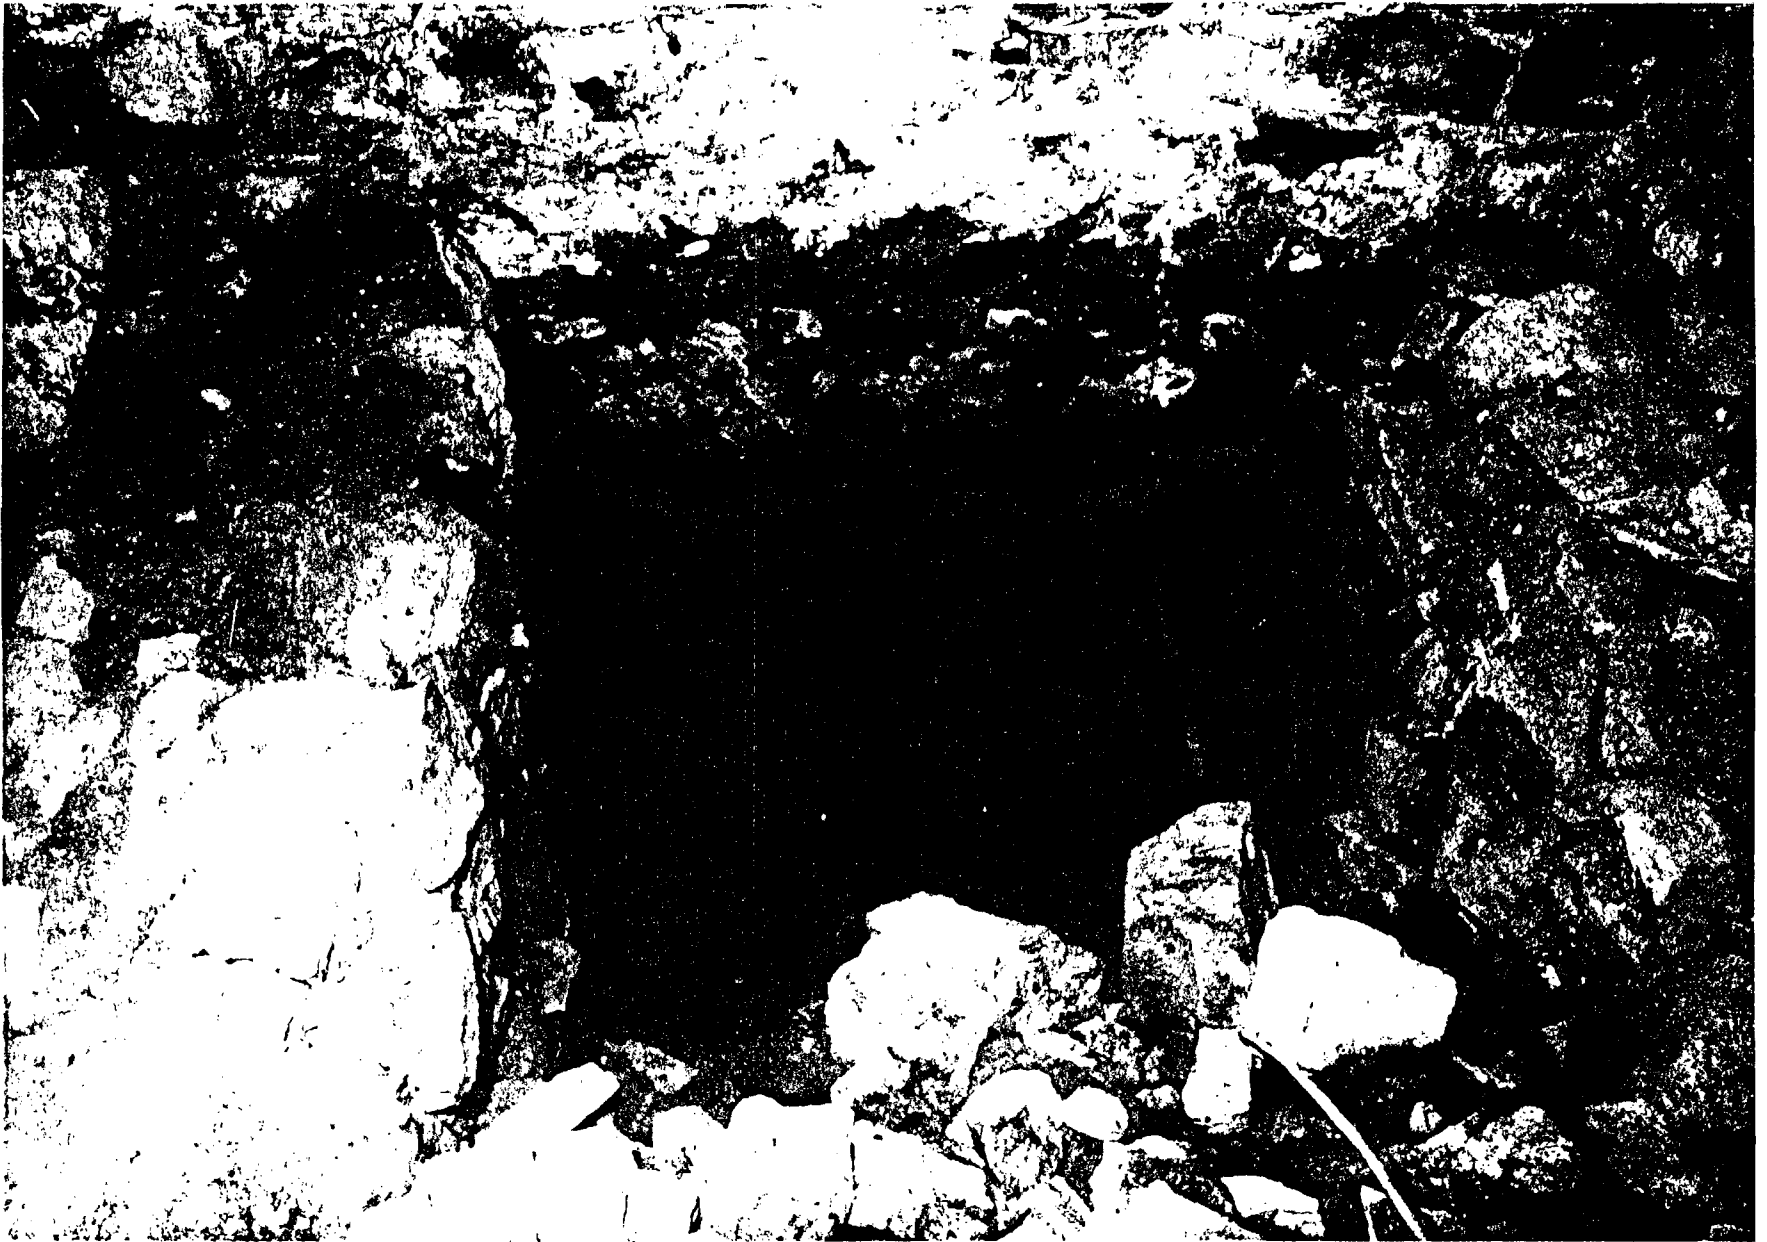
Figure 13. Limit of excavation unit 24H14G. (Photo by author; 24H-925M)

sand, clay and rock spall. At 1.53m below the surface (0.19m into this layer) the excavation ended due to an abundance of rocks and the unstable soil condition (Fig. 13). At this depth, unit 14G measured 1.25m east to west and 0.45m north to south. A number of 19th century artifacts were found in the top half of this layer.

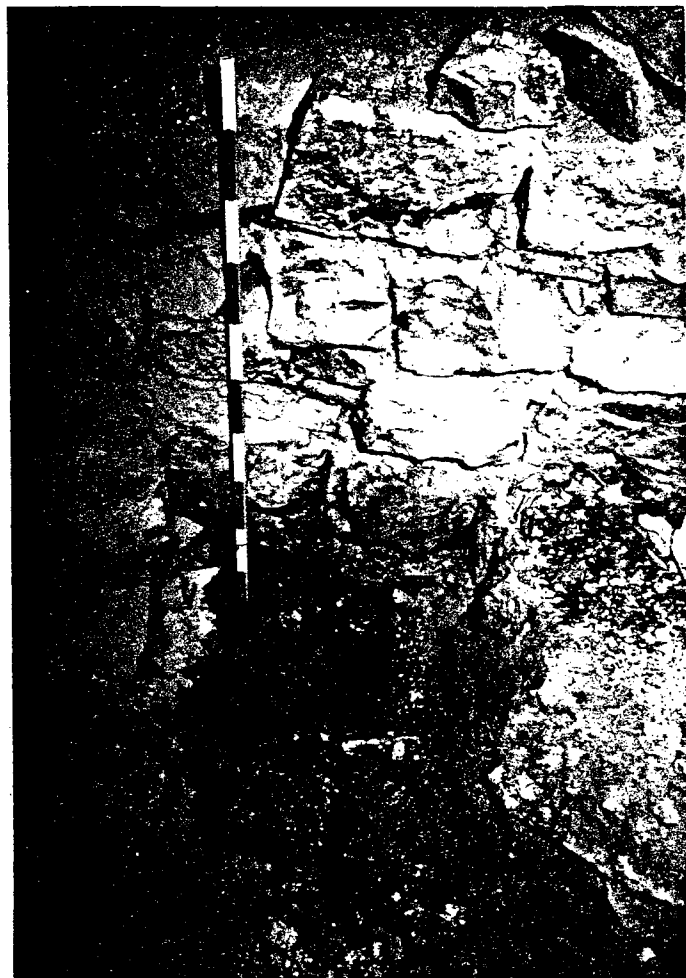
Figure 14. Detail of west side of center wall.  
(Photo by author; 24H-973M)

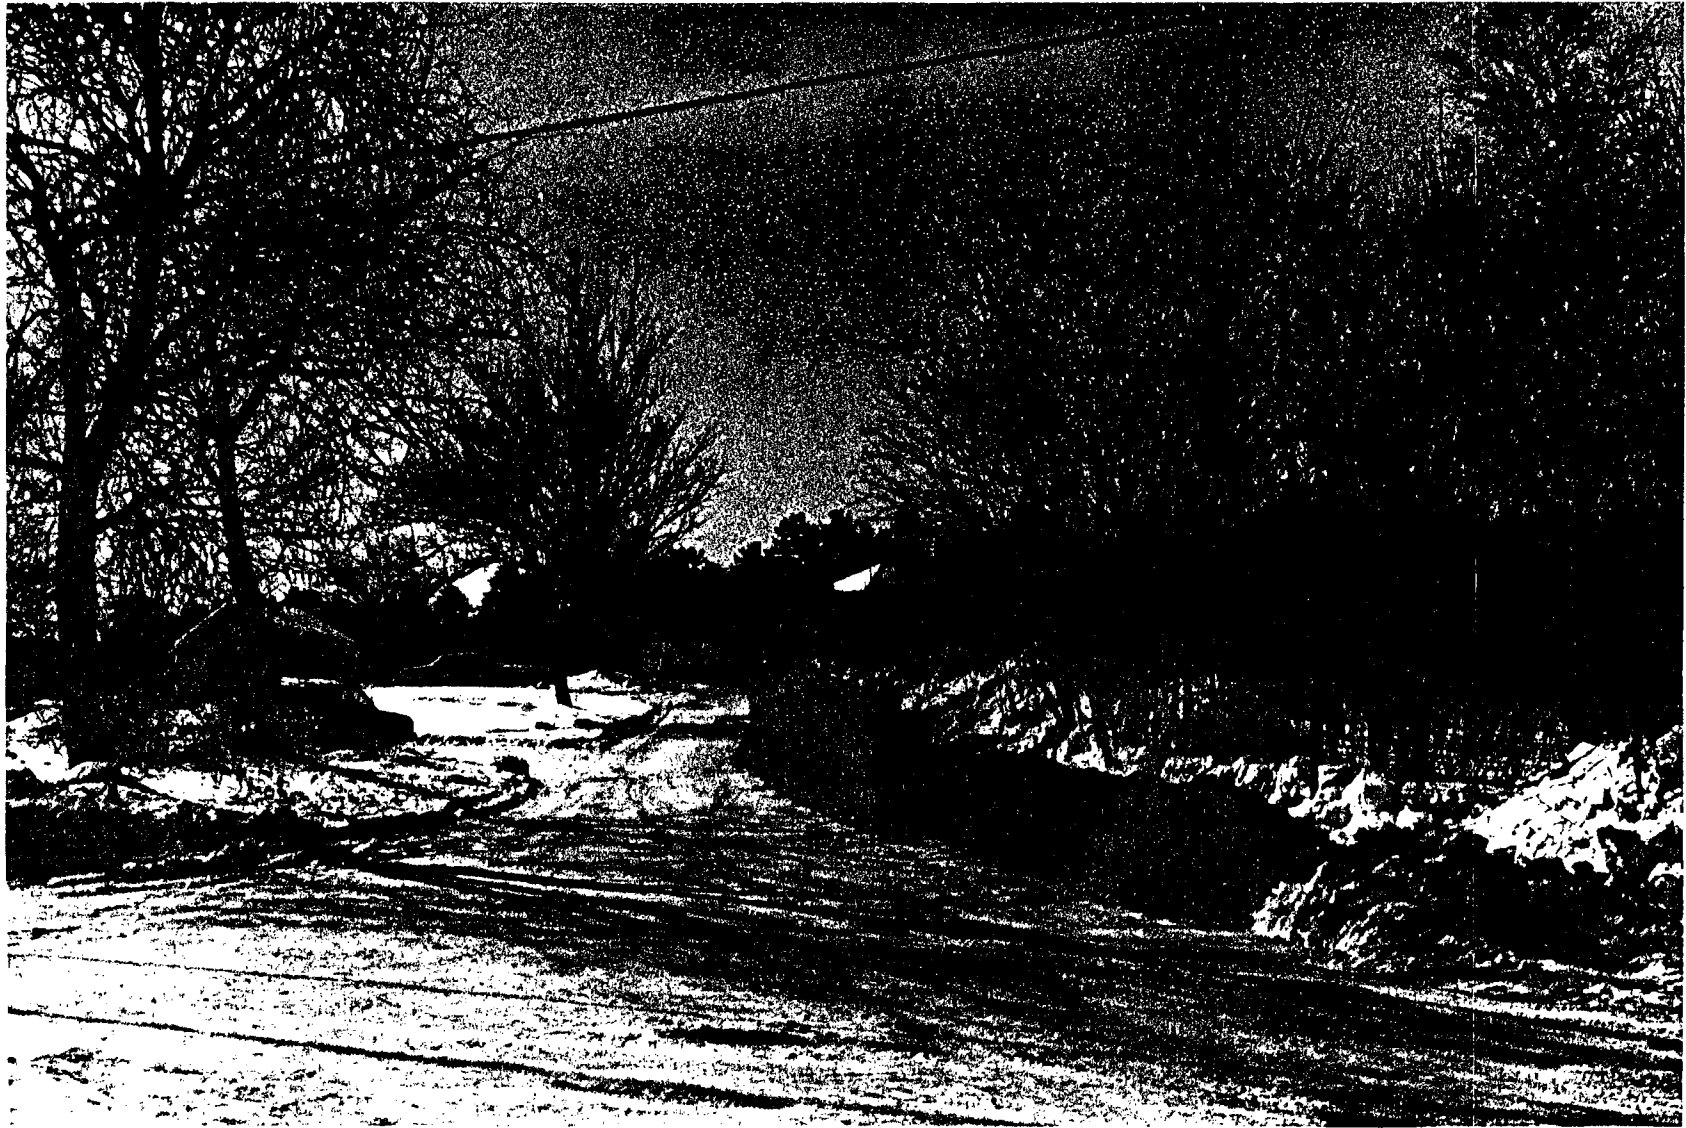
Figure 19. Powerline trench, unit 24H14N, looking south.  
(Photo by author; 24H-976M)

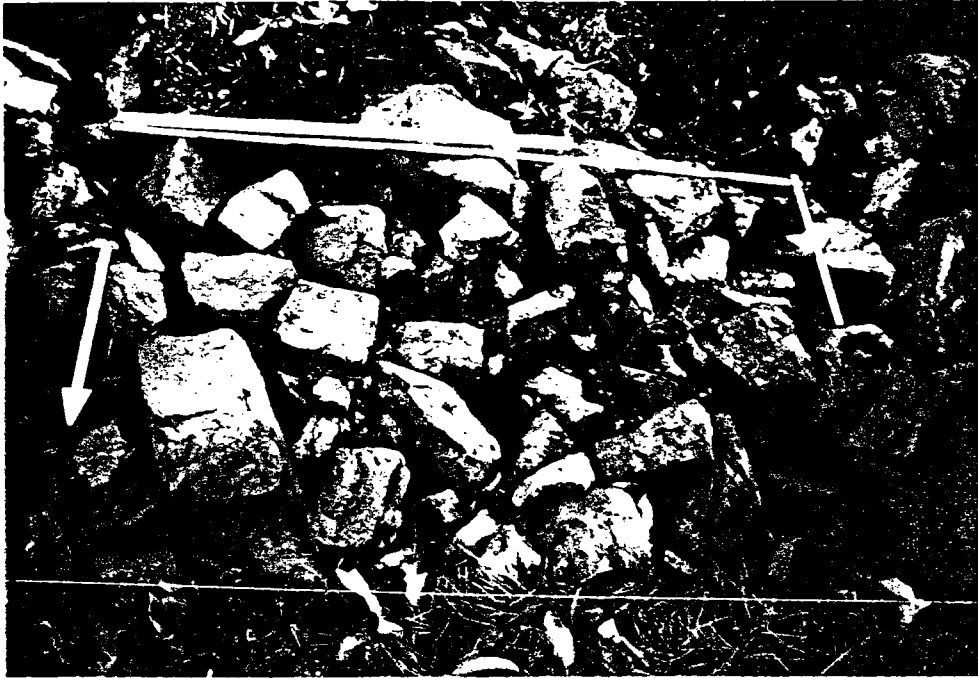
Figure 30. Cut stone debris north of foundation.  
(Photo by author; 24H-784M)

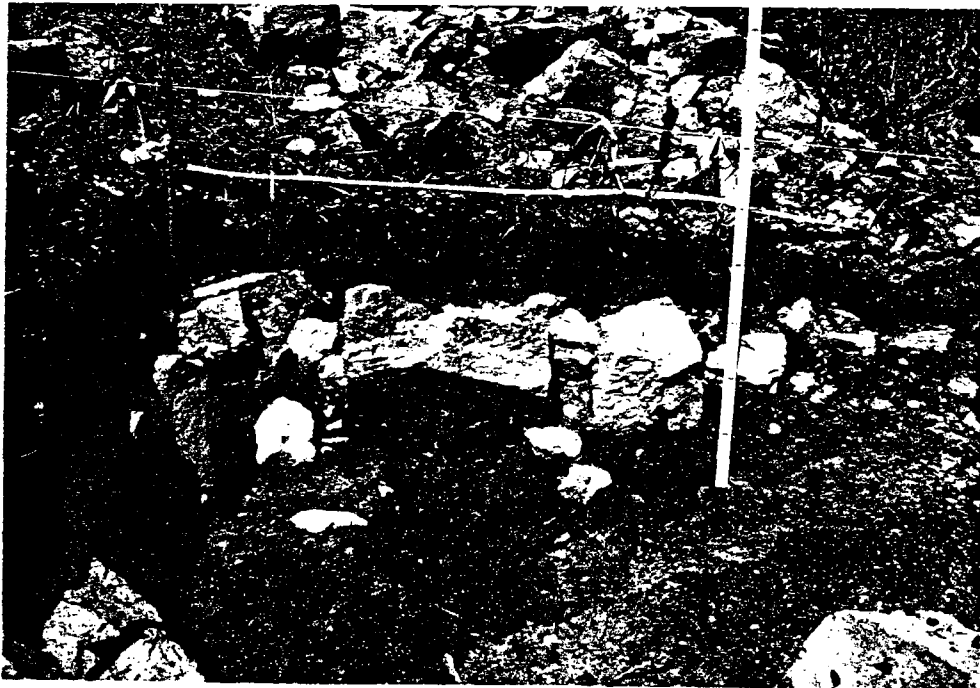
Figure 31. Section of north wall profile showing cut stone debris. (Photo by author; 24H-761M)

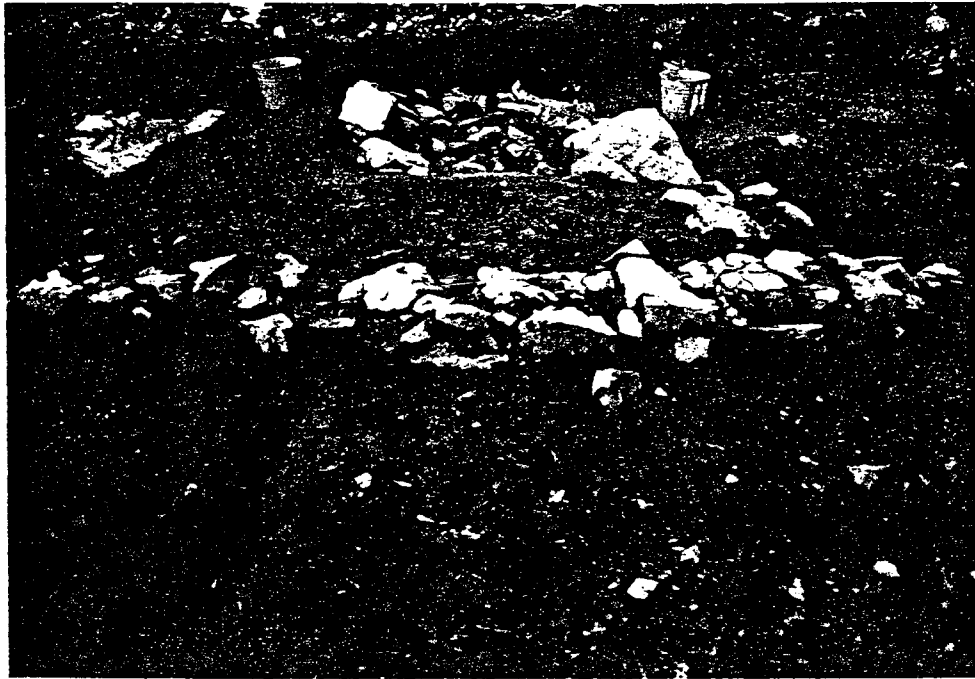
Figure 32. Carpenter's shop north wall foundation, facing south. (Photo by author; 24H-879M)

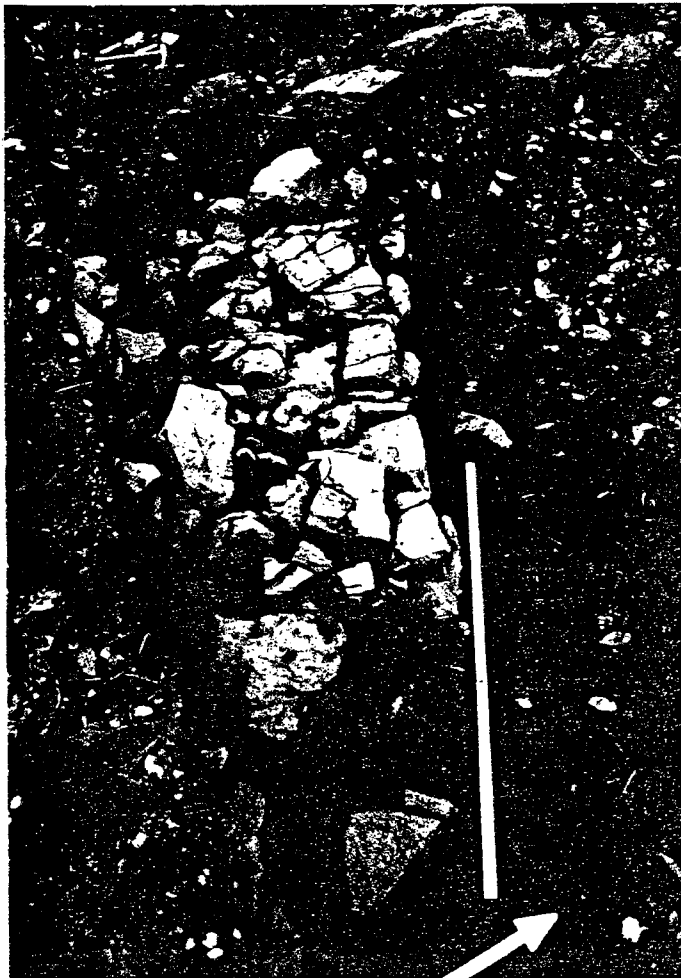
Figure 33. Carpenter's shop north side foundation, facing west. (Photo by author; 24H-827M)

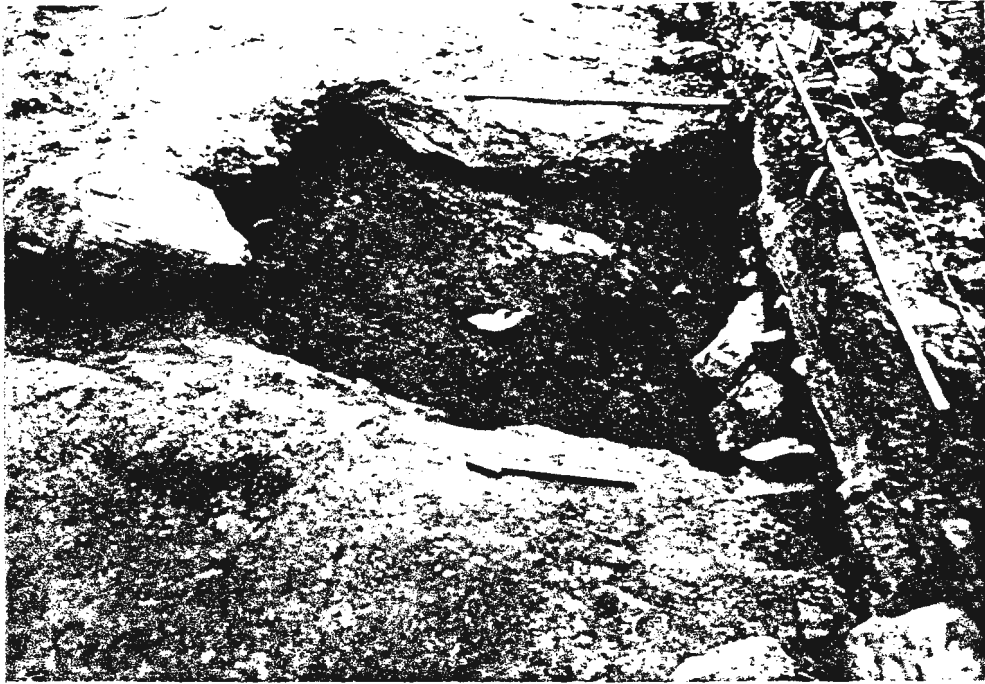
Figure 37. Excavated pit feature, facing east.  
(Photo by C. Phillips; 24H-889M)

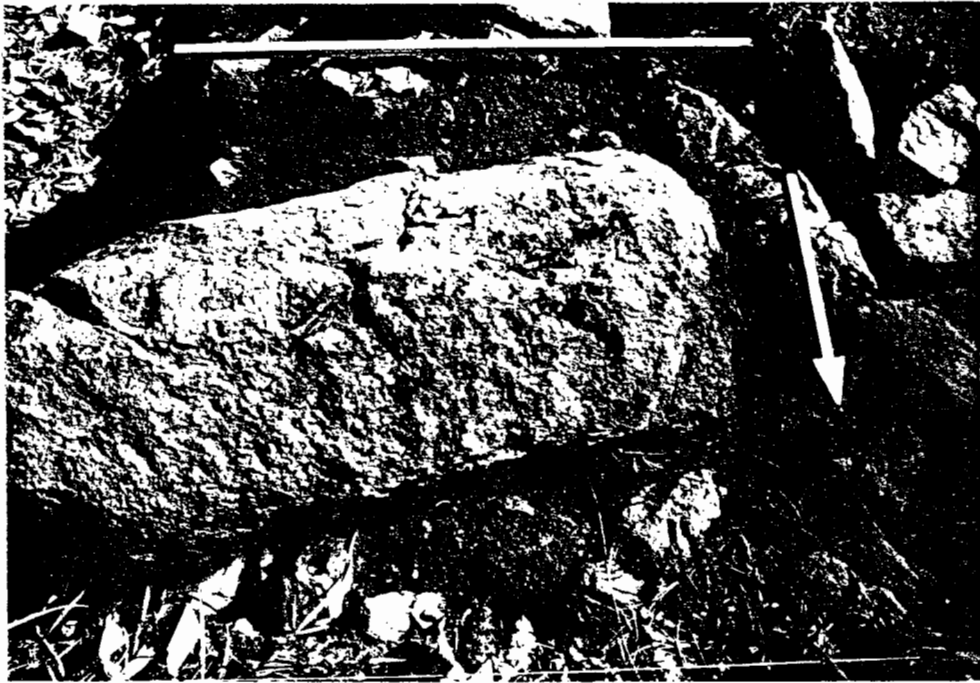
Figure 41. Dressed building stone in unit 24H14A7.  
(Photo by author; 24H-783M)
